ANALYSIS OF MUD MOTOR STALLS AND ITS IMPACT ON PERFORMANCE IN HIGH
TEMPERATURE UNCONVENTIONAL RESERVOIRS

A Thesis

ZACHARY IRA HOPKINS

Major Subject: Petroleum Engineering

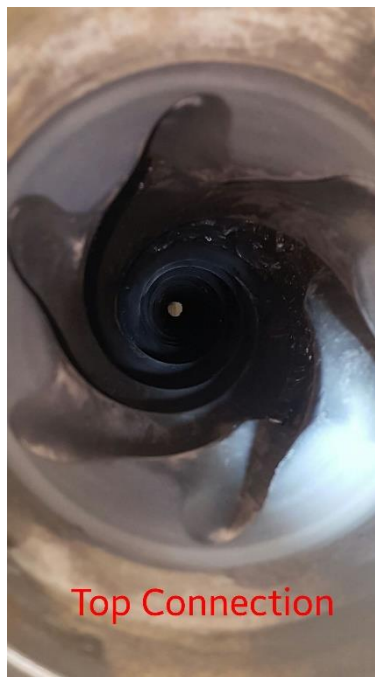
Fig. 4 – Upper stages of power section with little elastomer chunking

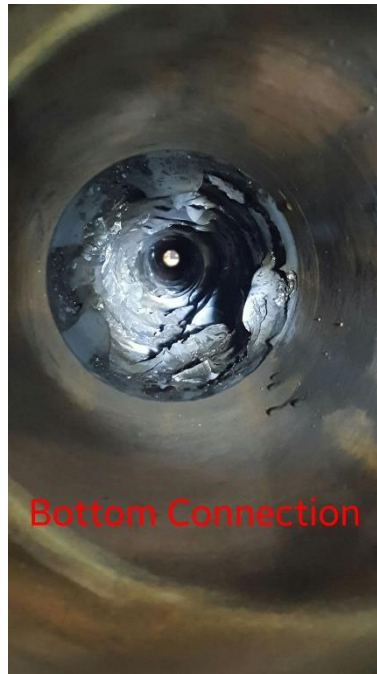
of the elastomer creates stress induced cracks (Samba et al, 2016). These stress cracks can propagate and may become large enough to fragment the elastomer leading to motor chunking. A motor that has been chunked can be seen in **Fig. 4** and **Fig. 5**. The elastomer will begin to fail from the lower stages of the power section towards the top, as the lower stages perform more work than the stages higher in the power section investigated by Denney et al (2012). From previous wells investigated, all motors do have some form of elastomer chunking. The severity of chunking will determine whether the motor can drill to total depth (TD) or not.

Fig. 5 – Lower stages of power section with elastomer chunking

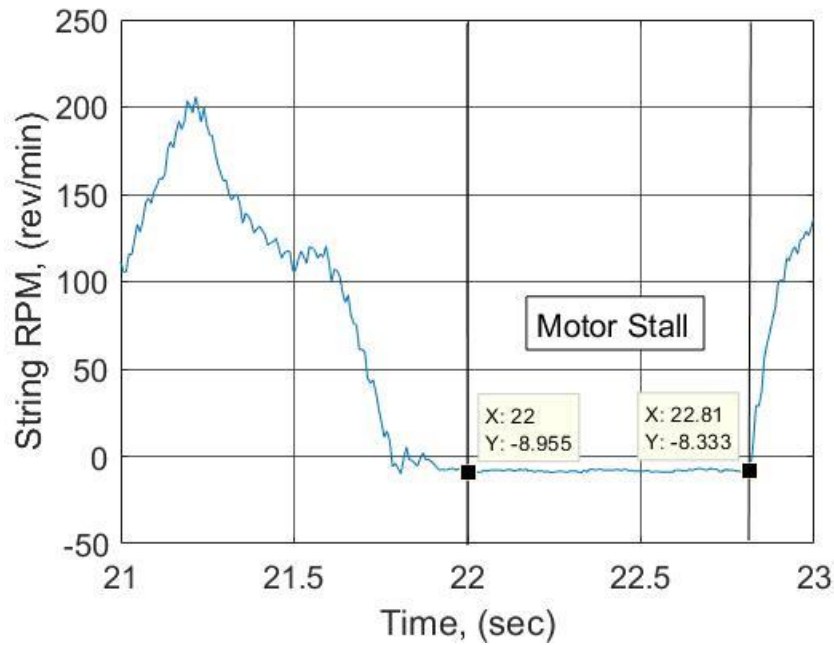
Fig. 9 – String RPM reaching zero and remaining stationary

The motor stalls observed were characterized by a halt in rotation of the string seen in Fig. 9. The string RPM is experiencing speed oscillation as expected and is a common occurrence seen while drilling (Dupriest et al, 2009). The speed oscillations stop and the string RPM approaches zero and comes to a complete stop. The differential pressure in Fig. 10 above

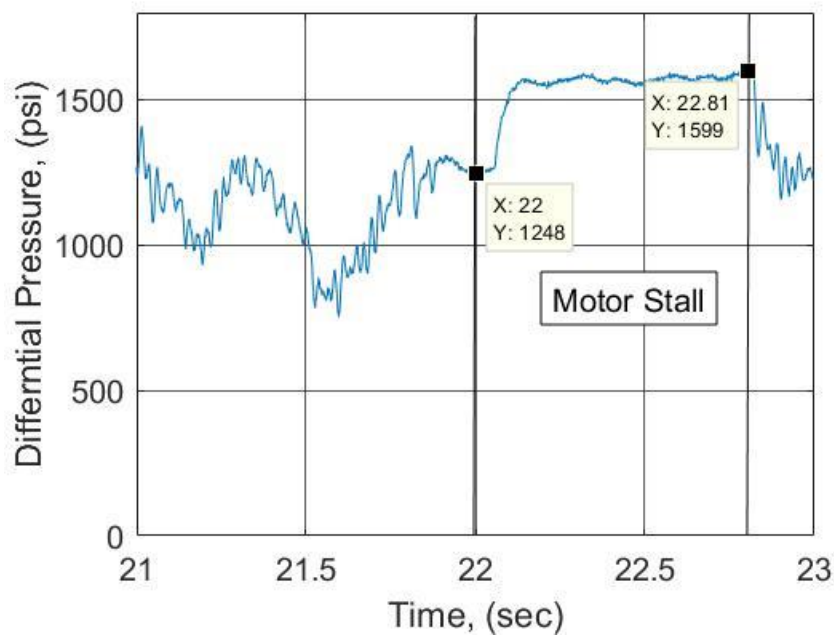
Fig. 10 – Differential pressure reaches a value suitable to stall motor

the motor is experiencing the same oscillations that the string RPM is experiencing, and then quickly climbs as the bit comes to a stop. It then reaches a peak of 1,600 psi which is well above the stall pressure of 1,100 psi as reported by the motor manufacturer. The torque in Fig. 12 also peaks to 16,000 ft-lbf and remains flat. The X accelerations seen in Fig. 11 show the string vibrating before the stall and once the stall occurs the accelerations stop and remain constant. The apparent cause of this stall can be seen as a sudden increase in weight that was applied due to weight transfer issues within the system shown in **Fig. 13**.

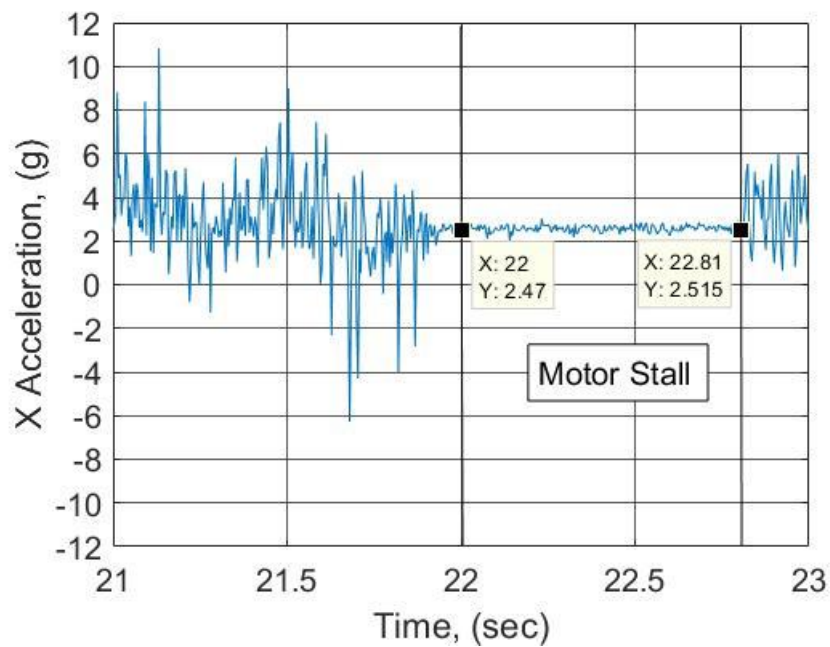
Fig. 11 – X accelerations hold constant during stall indicating the string nor the motor rotating

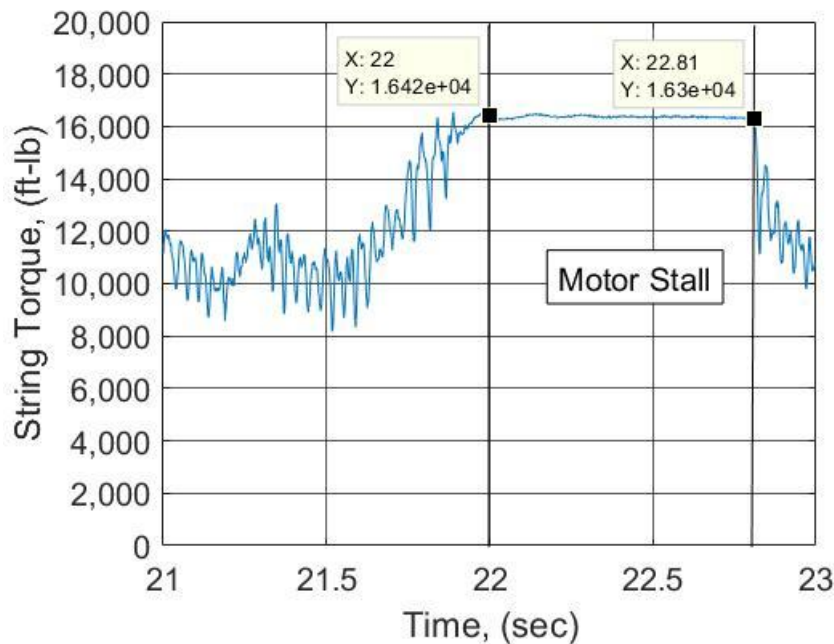
Fig. 12 – String torque peaks and remains constant as torque supplied through the motor and string is not suitable to rotate the bit

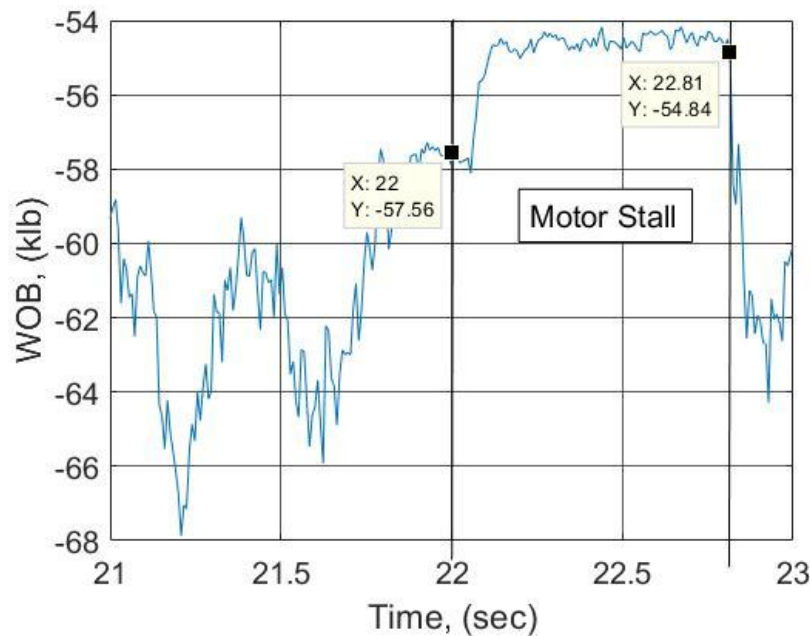
Fig. 13 – Sudden weight transfer to initiate stall and reduction in weight to release stall

The sensor readings for WOB are negative which was caused by an issue with the sensor, but the relative changes in WOB are correct. Beginning at 22 seconds a sudden increase in weight is applied which causes the motor stall. During the stall the top drive is still rotating the string and in turn is shortening it. The string has to shorten enough such that the torque required to rotate the bit reaches the value of torque supplied to the bit.

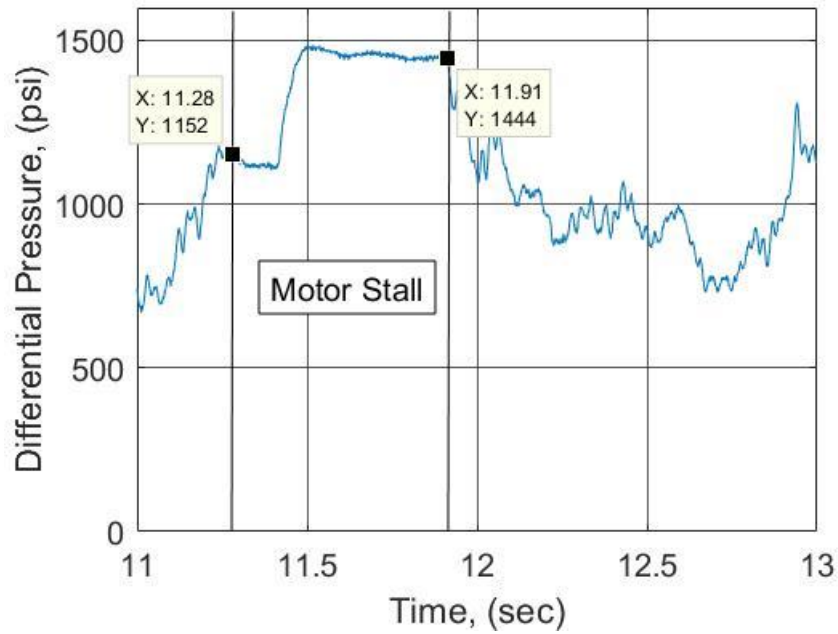
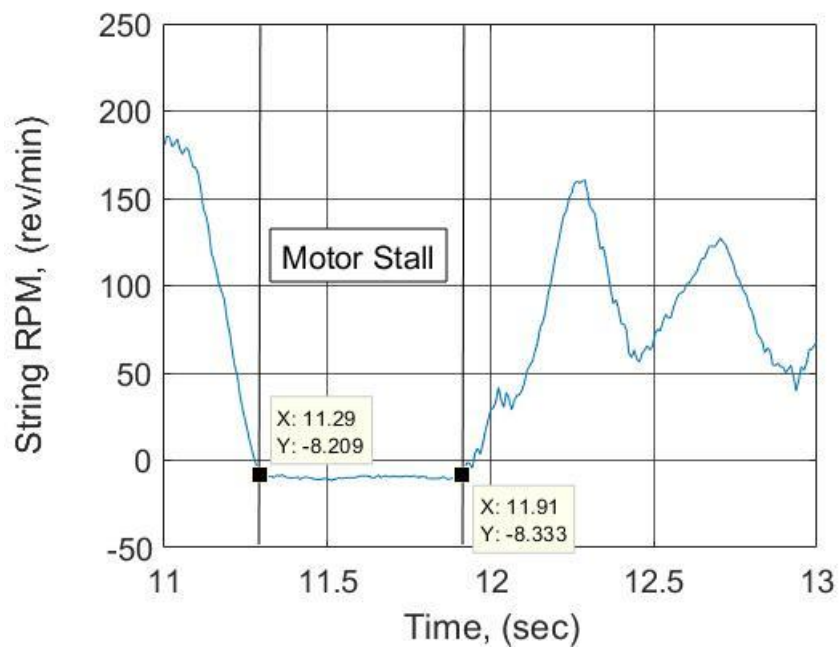
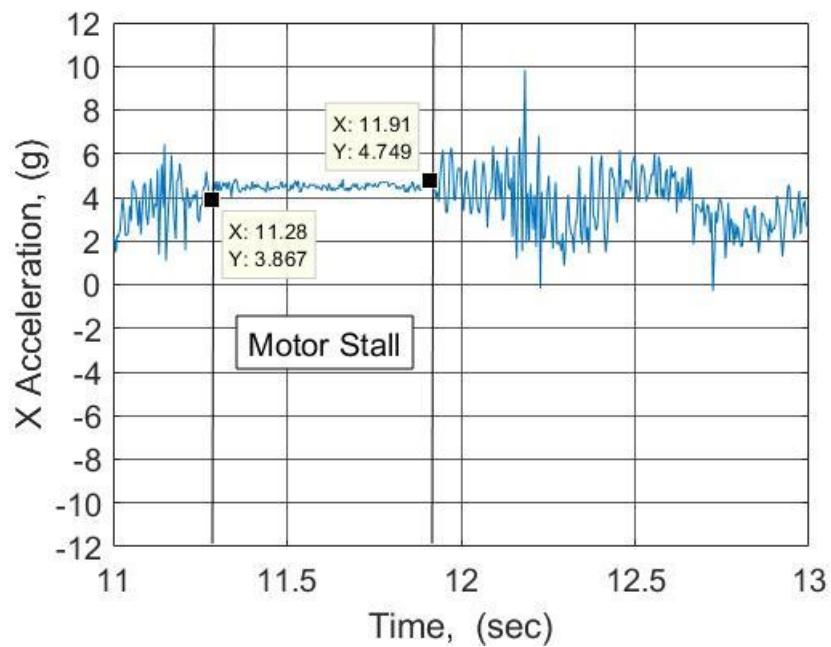
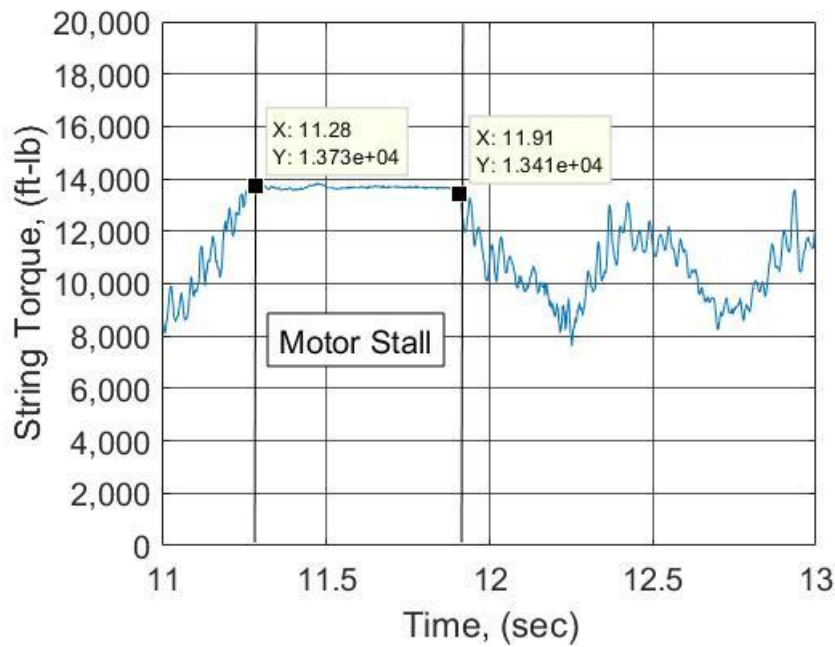
Fig. 14 – Differential pressure peaking to a value less than the previous stall

Fig. 15 – String RPM reaching zero in similar manner to first stall

Fig. 16 - X accelerations again remain constant indication zero rotation of string and motor

Fig. 17 – Torque reaches a peak that is less than the previous stall

The motor stall displayed in **Fig. 14**, **Fig. 15**, **Fig. 16**, and **Fig. 17** follows a similar process and shape to the previous stall. The only distinguishing feature in this stall is that the differential pressure required to stall and subsequent available torque is less. This is the cause of the frequency of motor stalls towards the end of lateral. Temperature continues to increase during drilling and as elastomer is lost the requirements to induce a stall are reduced. **Fig. 18** shows the average downhole stall pressure and surface pressure as well as the number of stalls during the last 8 hours of drilling.

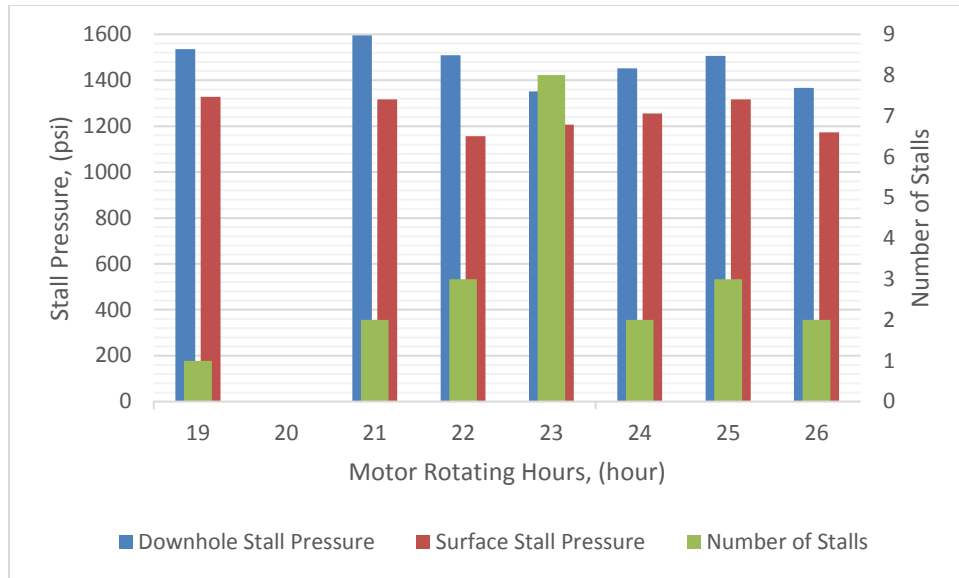
Fig. 18 – Reduction in downhole and surface stall pressure

The first four hours experienced 28% of the observed stalls and had an average downhole stall pressure of 1,546 psi. The latter four hours contained 72% of the observed stalls and the average stall pressure dropped to 1,419 psi. The 127 psi drop in average stall pressure is due to the damage the motor is incurring and the reduction of elastomer as discussed above.

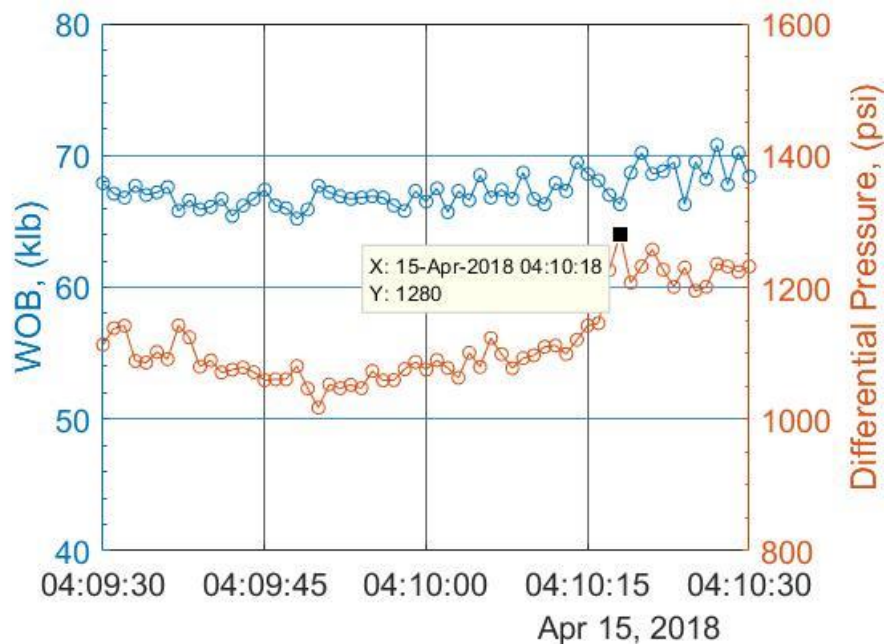
Fig. 19 – WOB drops as differential pressure peaks at 1280 psi

Surface measurements of the stall will be slightly behind the downhole measurements because of the time it takes for the pressure pulse and torque to reach the motor. The only indication that a stall may have occurred during this time is the differential pressure spike at 4:10:18. The 1600 psi differential pressure seen above the motor is not able to be seen at the surface. The erratic WOB before the observed stall at the surface could be an indication of weight transfer issues that ultimately caused the stall. The accelerations created by the varying WOB could allow the string to be released from something it is hanging up on and create the sudden jump seen Fig. 13. As stated previously the rated stall differential pressure for this motor is 1,100 psi and during drilling the motor was operating at or slightly above that value. As the differential pressure peaks it may not necessarily be cause for alarm as motors are routinely operated above their operating conditions all of the time. In reality the motor may be seeing significantly higher pressure that cannot be seen at the surface.

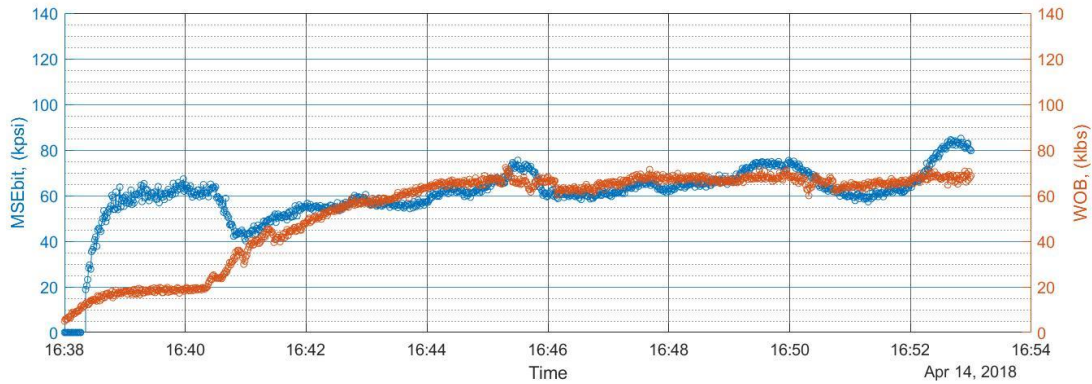
Fig. 20 – MSEbit response at the beginning of lateral showing baseline response

We can see that as we drill with 70,000 lbf WOB we are seeing an MSE_{bit} response ranging from 60,000 to 80,000 psi. As long as we are actively managing drilling inefficiencies and trying to keep the MSE_{bit} low we can use this value as the benchmark of motor performance using our current drilling parameters. We can make this same plot of a stand to see our baseline MSE_{bit} response further along the lateral. **Fig. 21** is from a depth of 14,180 ft, 2,922 ft from the previous stand.

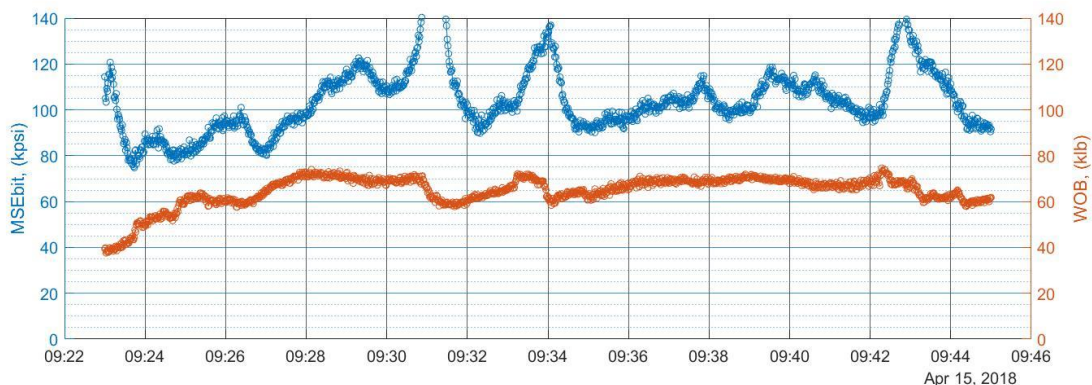
Fig. 21 – MSEbit response near the end of the lateral with higher baseline response

Fig. 20 if the motor has not been damaged and barring any changes in rock strength and drilling inefficiencies present. In this instance we see a much higher MSE_{bit} response, ranging from 90,000 psi to 140,000 psi. Step tests performed further in the lateral show that the overall inefficiency in the system has not changed much and that these plots demonstrate that the motor has been damaged and is not producing the same torque and rotation that it once was. The MSE_{bit} response naturally increases in the lateral due to weight transfer issues, but because the well has a shorter than average lateral length this issue should not create the significant change as shown in Fig. 20 and Fig. 21.

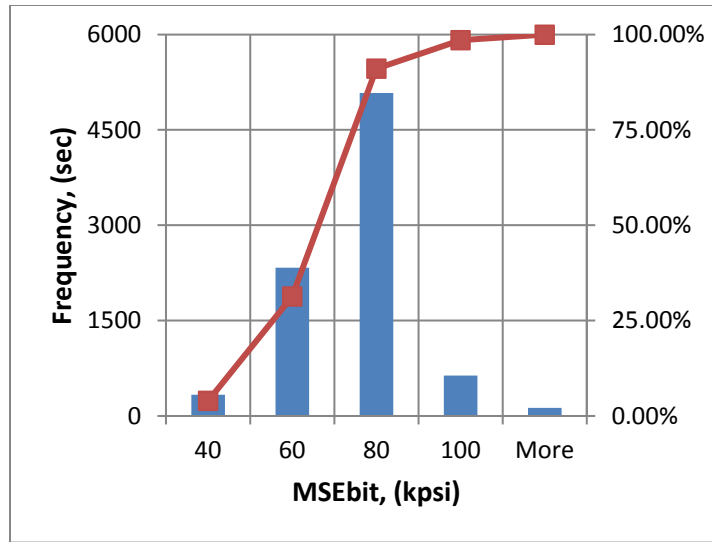
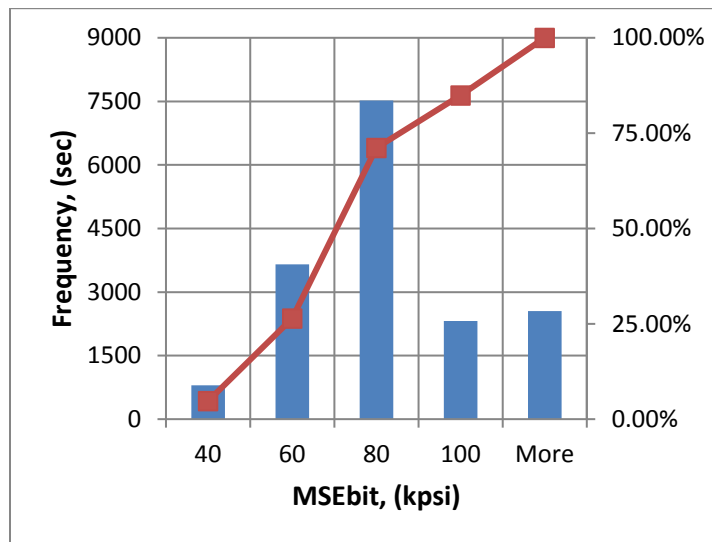
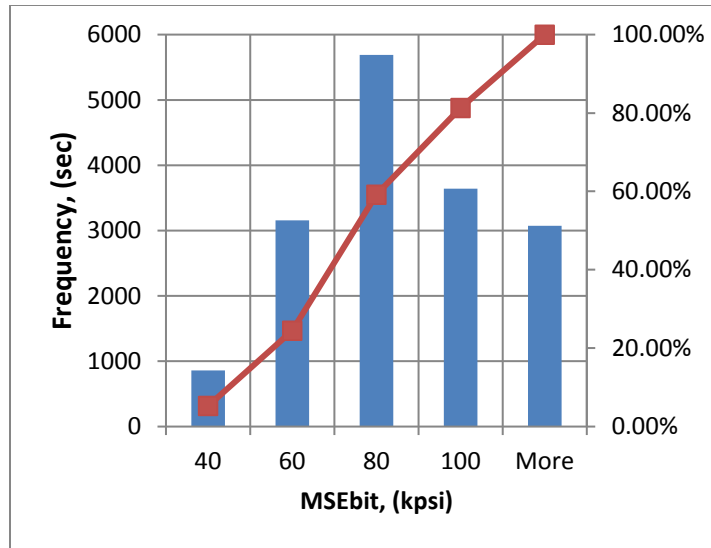
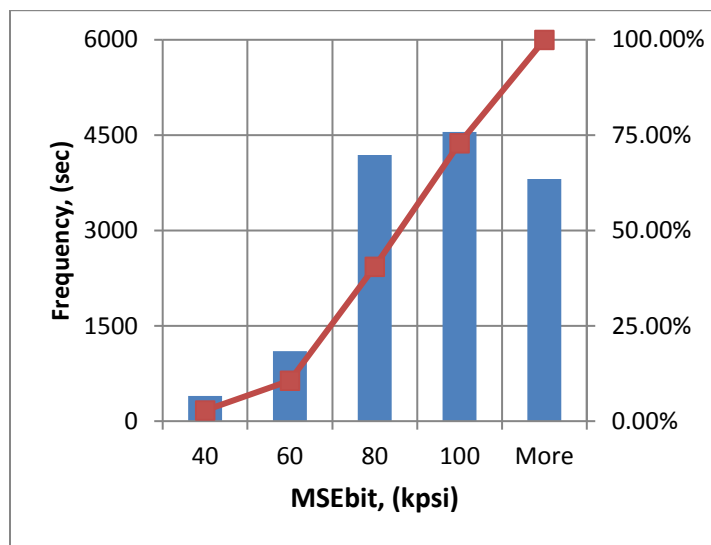
Fig. 22 – Majority of MSEbit is less than 80,000 psi as expected

Fig. 23 – MSEbit increases over the next 3 hours of drilling as motor is damaged

Fig. 24 – MSEbit continues increasing as motor damage accumulates

Fig. 25 – Over 50% of drilling in the last 3 hours is above our baseline response in the lateral

These figures illustrate that as drilling is continued in the lateral the MSE_{bit} response continues increasing. During the last 3 hours of drilling over one and half hours has an MSE_{bit} response greater than 80,000 psi. In contrast to the first 3 hours of drilling the lateral where only 16 minutes of drilling had an MSE_{bit} response greater than 80,000 psi.

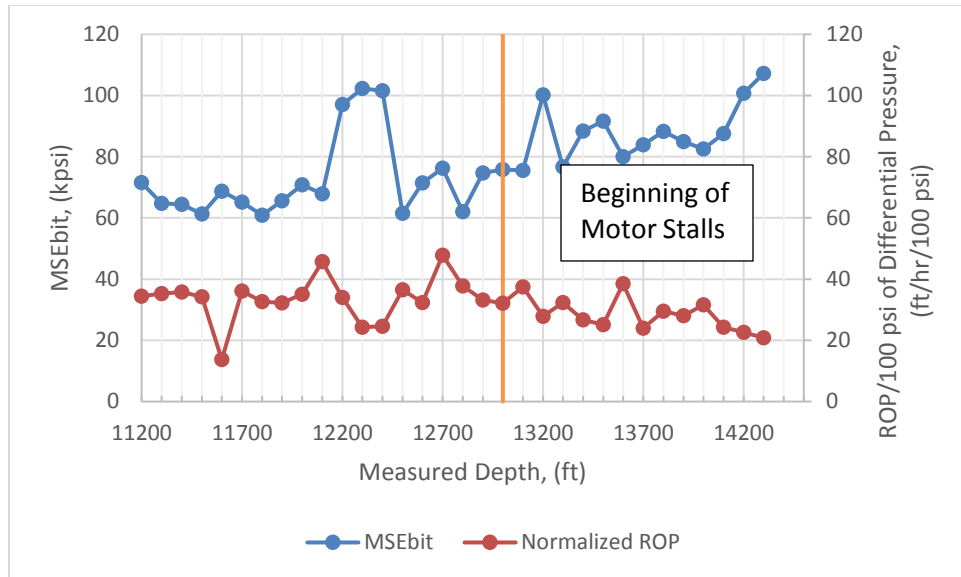
Fig. 26 – The slope of pressure normalized ROP becomes is flat before the stalls and becomes negative once the stalls begin

At the beginning of the lateral section the normalized ROP is fairly constant and does not appear to trend down. At approximately 13,000 ft measured depth, the stalls begin and the slope of pressure normalized ROP begins to become negative indicating damage.

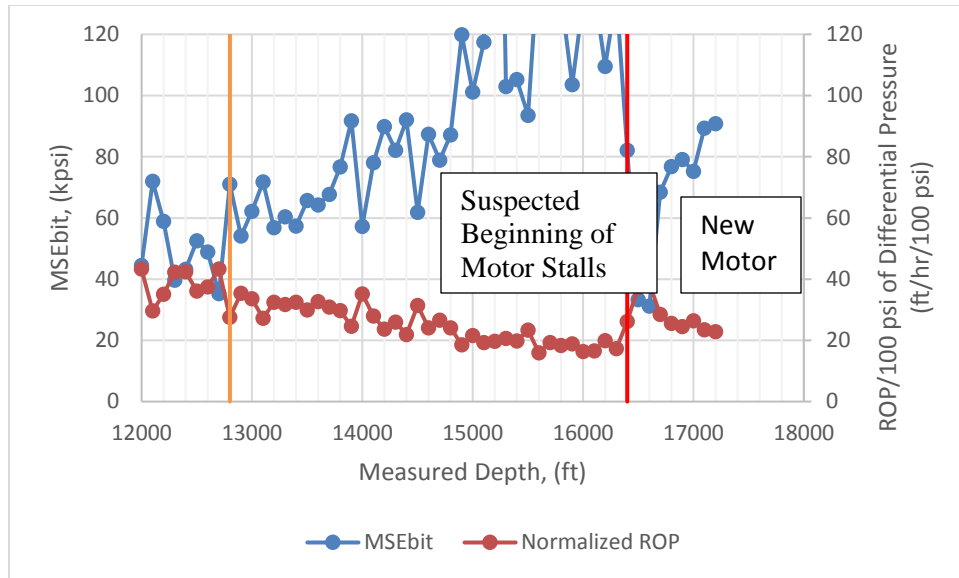
Fig. 27 – Suspected start of motor stalls occurring at 12,800 ft and increased in performance when motor was replaced at 16,400 ft.

Following the same logic as on the previous well, once motor stalls begin to occur, pressure normalized ROP should begin to drop. This places the suspected beginning of stalls occurring at 12,800 ft, at which point performance degrades until the motor had to be replaced at 16,300 ft. Once the motor was replaced the pressure normalized ROP and MSE_{bit} values improved significantly because the motor is undamaged, but then quickly begin to degrade within 300 feet indicating that motor stalls are once again occurring. Using this approach to find the approximate depth that motor stalls begin occurring, allows operating parameters to be reduced to reduce the frequency of stalls and prolong life of the motor.

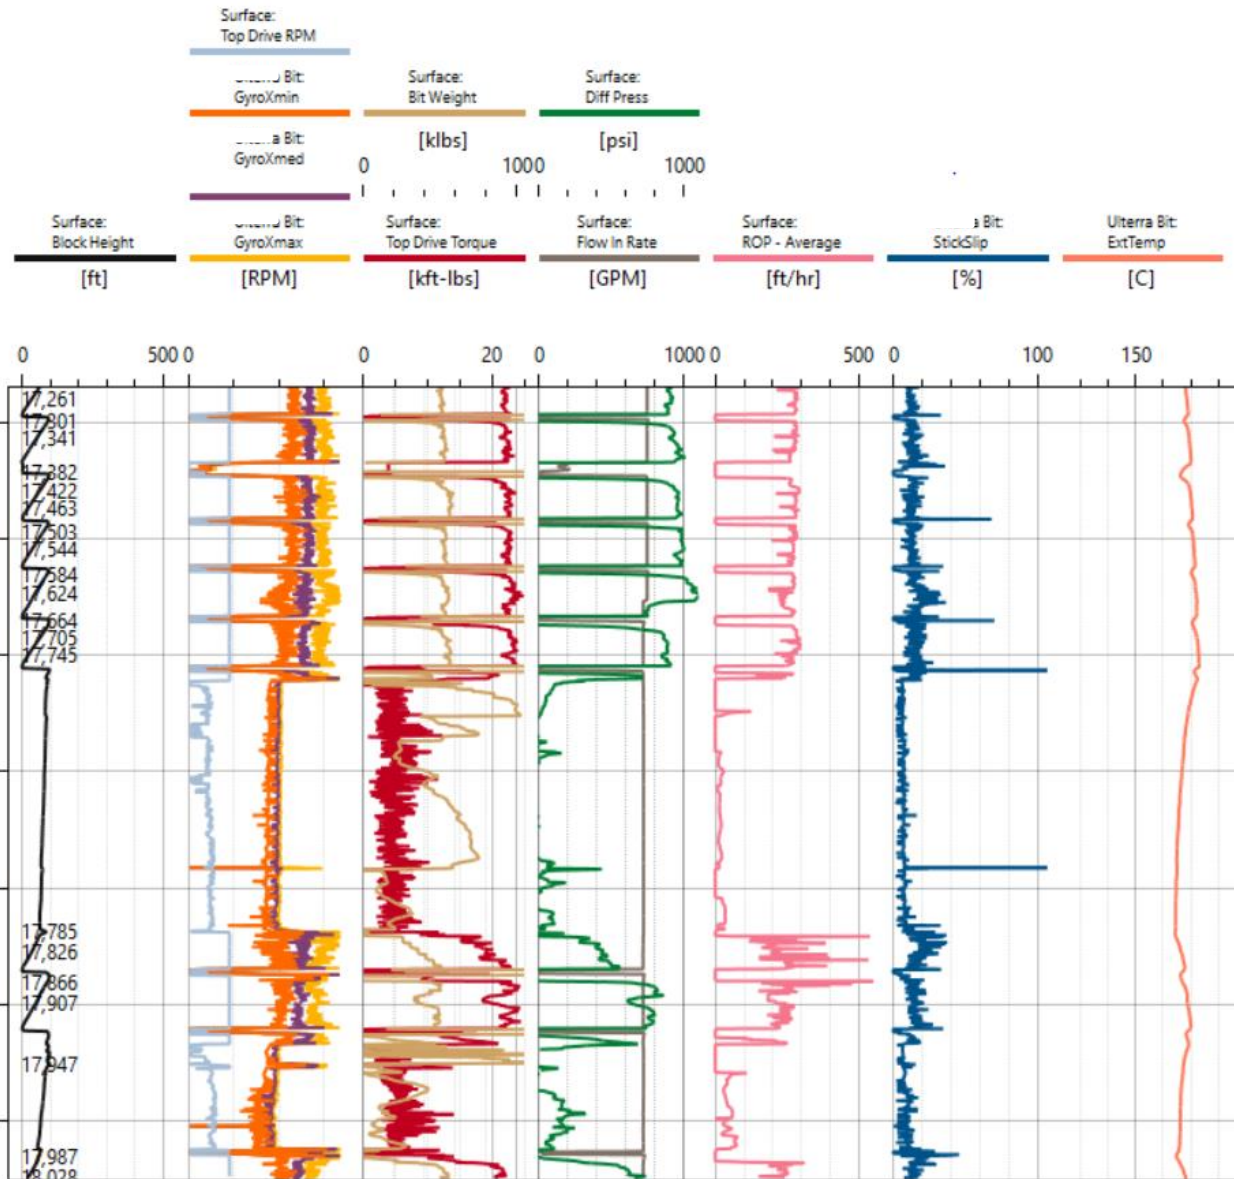
Fig. 28 – Bit external temperature cools down during slide from 17,745 to 17,785 ft

This sensor was located within the bit and not located near the motor, but the motor will be experiencing the same cooling down and heating up during slides and rotations, just at a lower temperature as it is further up the string. The slide occurs between 17,745 and 17,785 ft demonstrating the cooling down of the bit during periods of no rotation. The bit cooled down

roughly 14°F which may not seem like much, but when temperature is 300°F plus, a small reduction in temperature can have a big effect on motor damage and stalls.

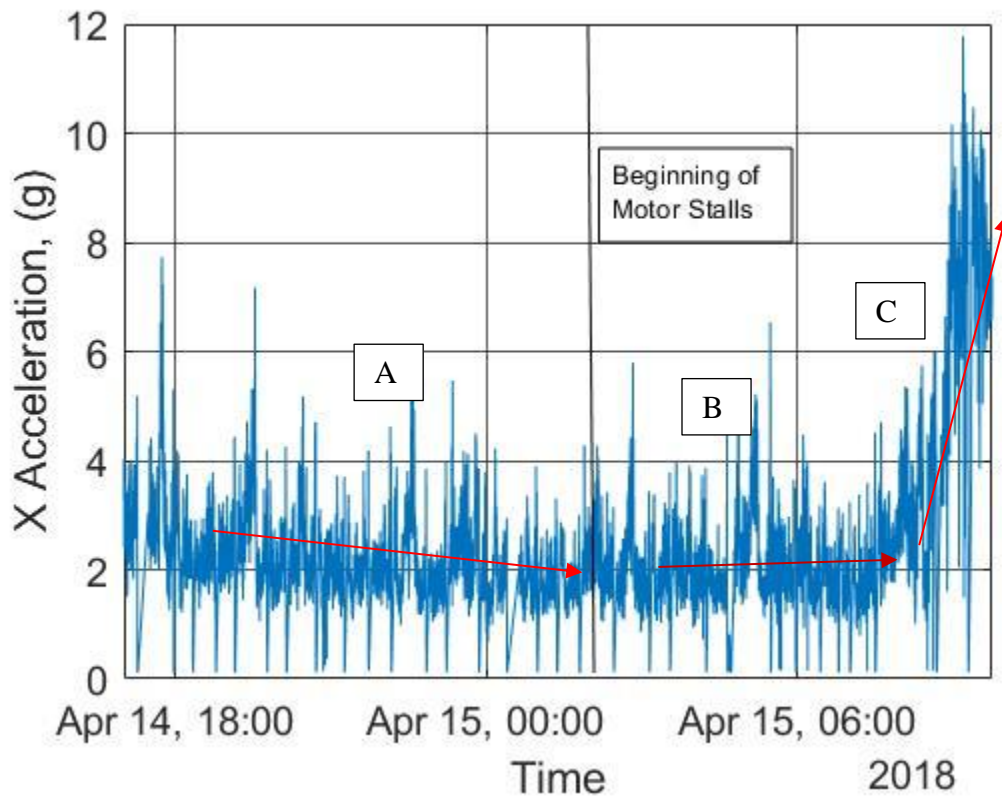
Fig. 29 – Accelerations remain constant before beginning of stalls (A) and slightly increase after stalls begin (B) until quickly climbing towards the end of the lateral (C)

Constant two g vibrations are experienced downhole during periods of rotation. This further demonstrates the violent collisions that are occurring during periods of rotation and why the temperature rises so much during rotation and cools down while there is no rotation. The vibrations also increase once the motor becomes significantly damaged. This further increases the heat generation and reduces the requirements to stall the motor.
